19th CENTURY HOUSES OF OLD CAIRO QUARTERS

Salah Zaky Said

المجلس الأعلى للثقافة

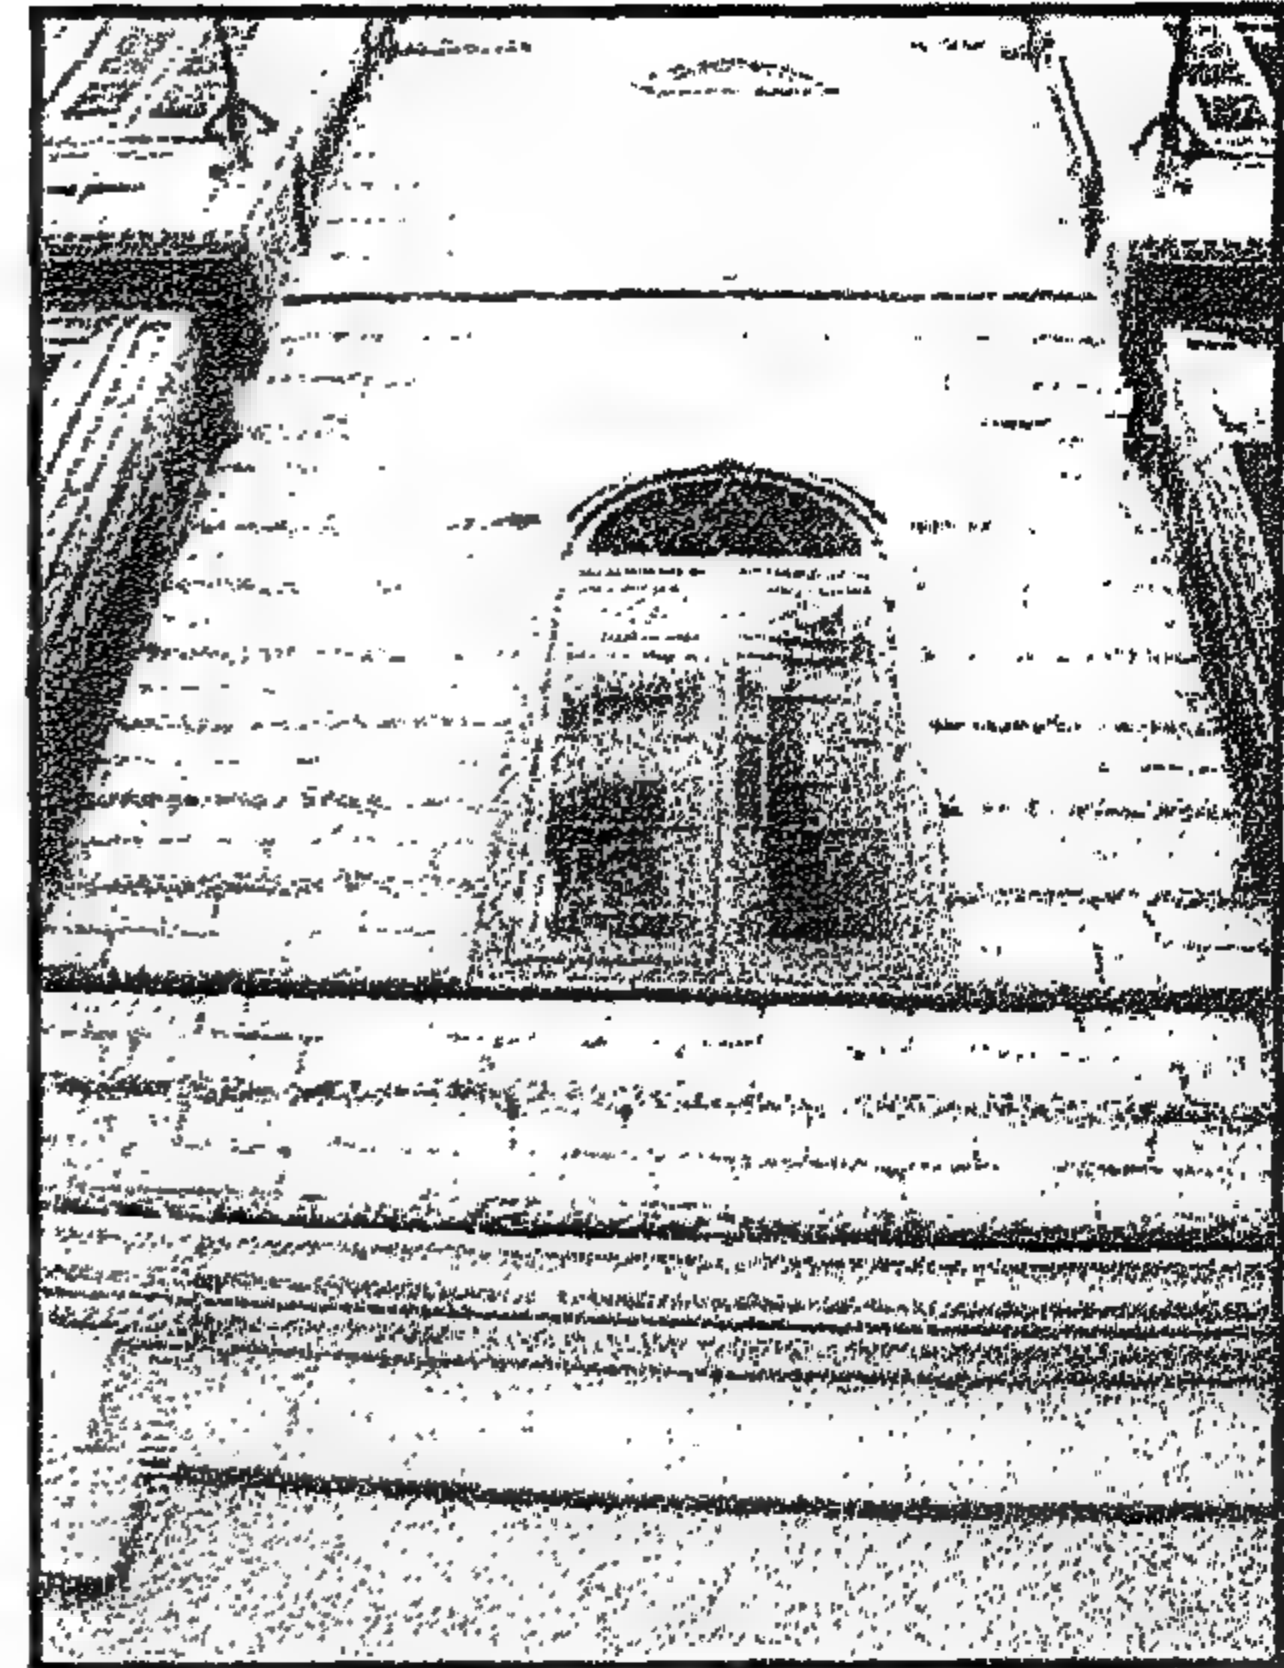
Figure 5-22 Stone façade in Bayt Abu al-Hasan after cleaning (September 2005)
